**DEPARTMENT OF TRANSPORTATION****DIVISION OF ENGINEERING SERVICES**

Contract #: 04-0120F4Cty: SF/ALA Rte: 80 PM: 13.2/13.9File #: 69.28**WELDING INSPECTION REPORT****Resident Engineer:**Pursell, Gary**Address:** 333 Burma Road**City:** Oakland, CA 94607**Report No:** WIR-002911**Date Inspected:** 11-Jun-2008**Project Name:** SAS Superstructure**OSM Arrival Time:** 630**Prime Contractor:** American Bridge/Fluor Enterprises, a JV**OSM Departure Time:** 1530**Contractor:** Zhenhua Port Machinery Company, Ltd (ZPMC), Changxing Island **Location:** Shanghai, China**CWI Name:** Hu Wei Qing and Lvliqing**CWI Present:** Yes No**Inspected CWI report:** Yes No N/A**Rod Oven in Use:** Yes No N/A**Electrode to specification:** Yes No N/A**Weld Procedures Followed:** Yes No N/A**Qualified Welders:** Yes No N/A**Verified Joint Fit-up:** Yes No N/A**Approved Drawings:** Yes No N/A**Approved WPS:** Yes No N/A**Delayed / Cancelled:** Yes No N/A**Bridge No:** 34-0006**Component:** OBG and SAS Tower Fabrication**Summary of Items Observed:**

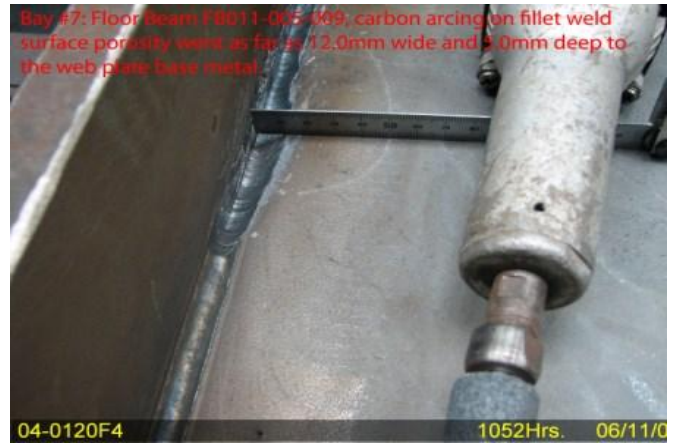
Flange to web plate fillet weld removal by carbon air arcing on floor beam sub-assembly FB011-005-009 and FB011-005-017 due to noted elongated and rounded surface porosity was observed. During the removal process, the carbon arc operator went 5.0mm too deep and 12.0mm wide into the web plate base metal. Since this is more than the Code ASTM A6 Paragraph 9.2.1 allowed, ABF Inspector informed ZPMC to make request to Caltrans for

base metal repair. See photo below.
